**Volume 28, Number 2  
December 2022**

Article -- Author	Page
<b>Reassessing domestic space in the Amarna Workmen's Village</b> <i>Thais Rocha da Silva</i>	1
<b>Nature Paintings in the North Palace at Amarna</b> <i>Barry Kemp &amp; Christopher Stimson</i>	11
<b>Excavation in the Vicinity of the East Gateway</b> <i>Fabien Balestra</i>	32

# Reassessing domestic space in the Amarna Workmen's Village

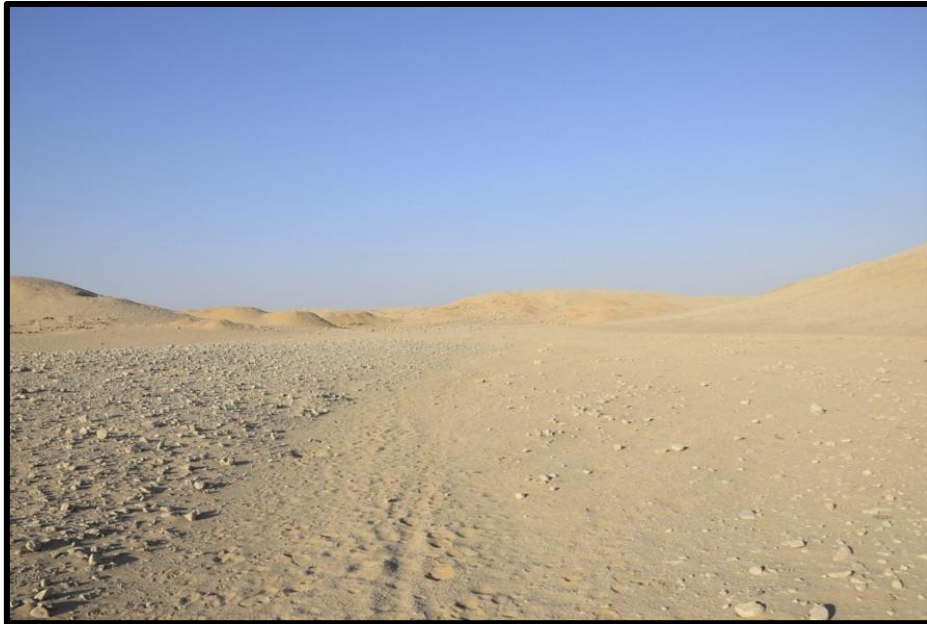
**Figure 2:** *Current path towards the Workmen's Village. Looking Northwest (Photo by the author).*

The Workmen's Village, previously called the 'East Village' by Peet and Woolley, comprises a mud-brick wall that encloses 72 very similar houses, distributed in 5 parallel streets. The main entrance to the village is from the south, and the walled settlement is surrounded by slopes that keep it protected from the winds and partially hidden in the landscape (Figures 1, 2). The Workmen's Village was connected to other parts of the city by a network of roads and trails still seen in the desert, indicating a complex system of supply deliveries, such as water, pottery, working materials and clothes (Figure 3). But these roads could also keep the village isolated from those who did not belong to the community and were probably patrolled by the state.

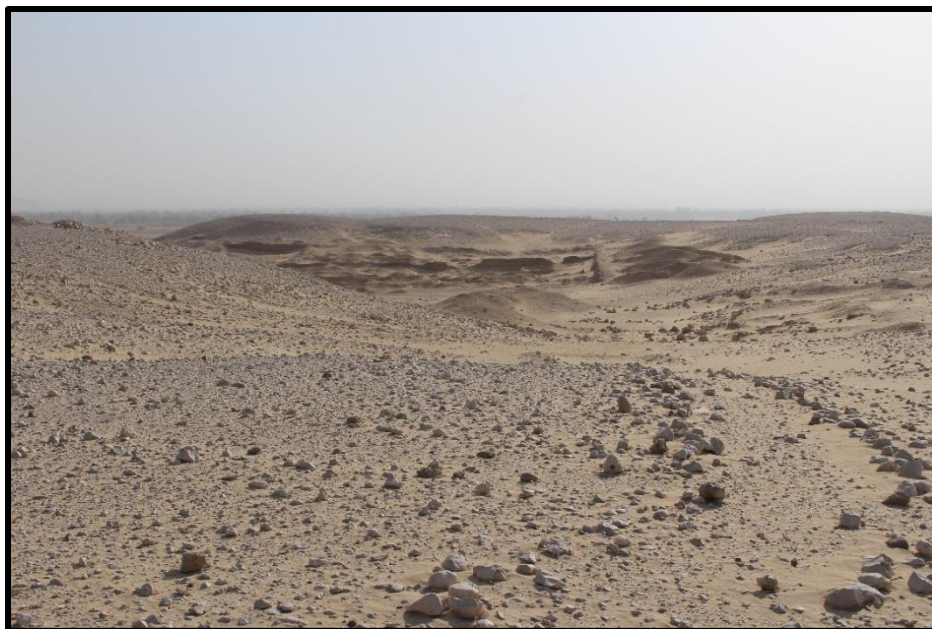
**Figure 3:** *Mark of a road leading to the Workmen's Village (Photo by the author).*

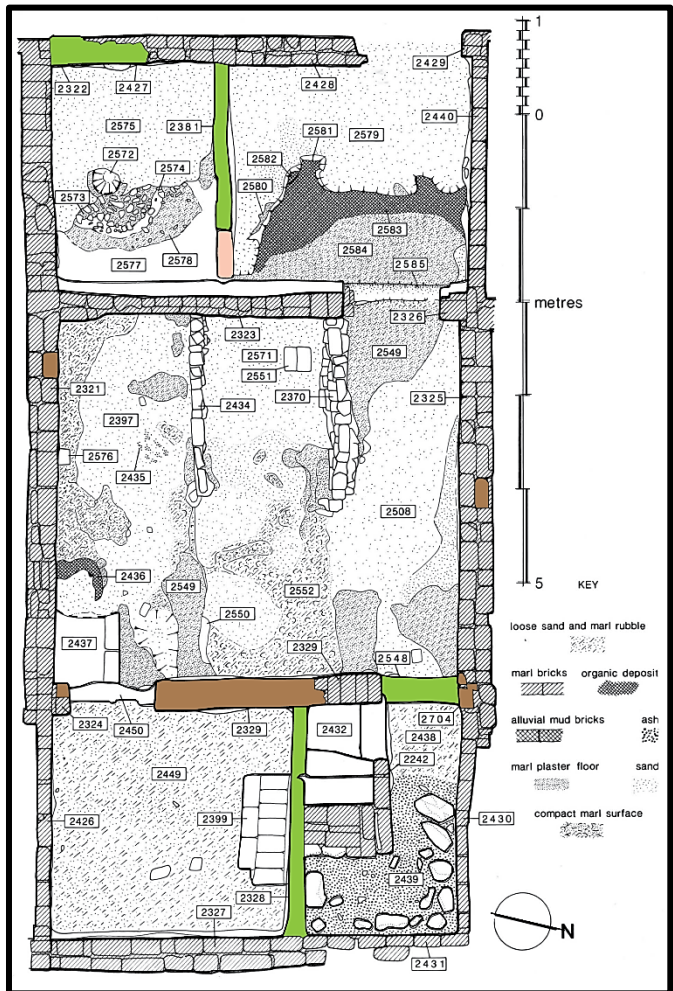
**Figure 5:** Plan of Gate Street 9 indicating added walls (green and pink), and alluvial mudbrick (brown) (after Kemp 1984; 1986).

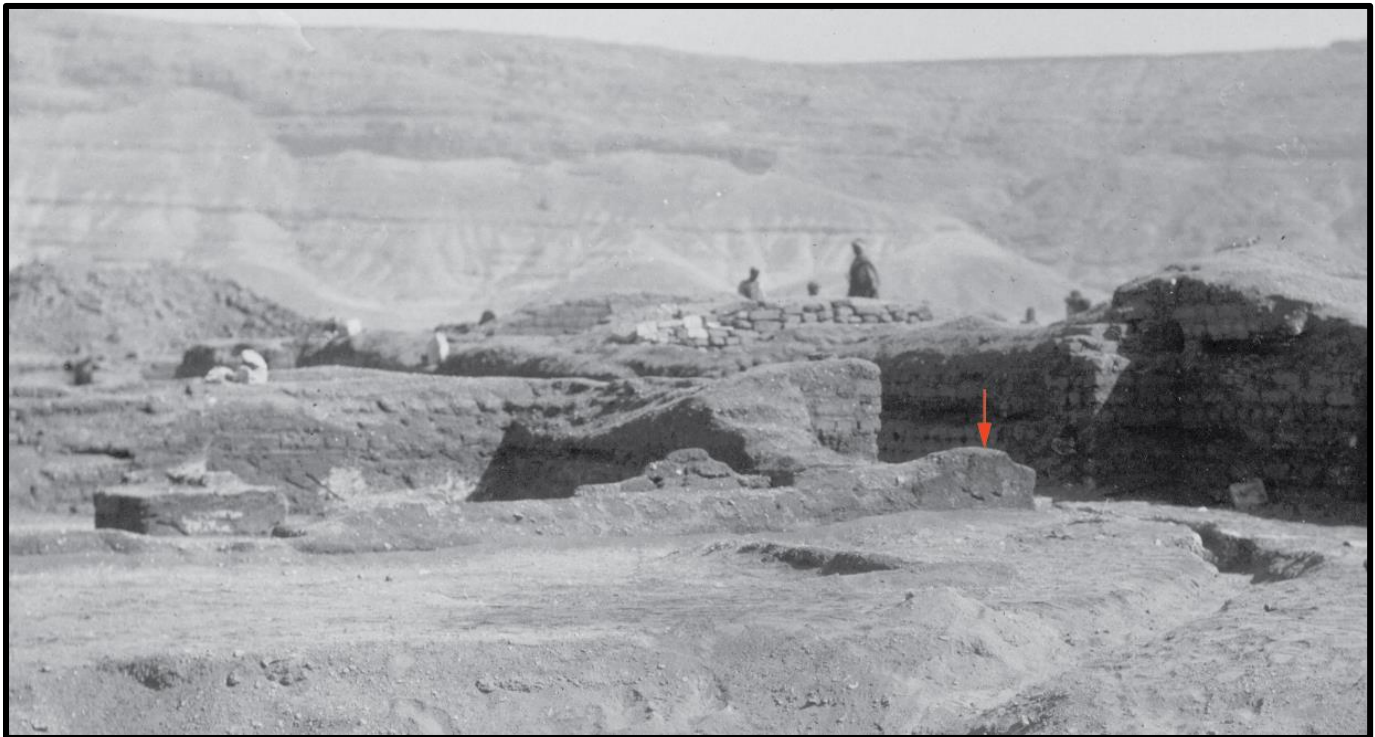
**Figure 3:** *Excavation photograph (1924) which includes the portion of the outside wall of the eastern animal court. The red arrow marks the position of the fragment of painted waterbank scene which was 56 cm high. View to the north-east. EES photo 1924–5/88.*

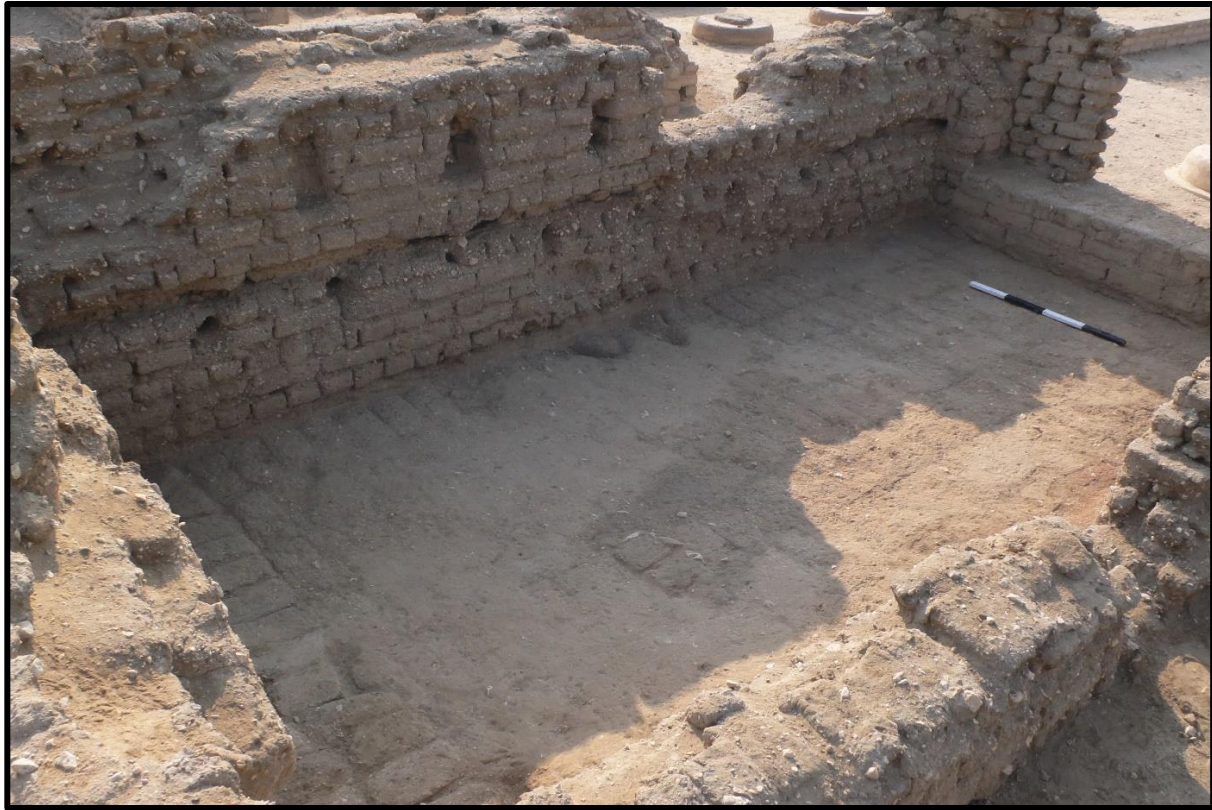
**Figure 7:** View, to the south-east, of the interior of the Green Room (room 12) in the North Palace, after cleaning in October 2011. The sill of the large window has been built up afresh, the rough brickwork on the left side (facing the viewer) belonging to protective work carried out in 1926 when the room was temporarily roofed and parts of the wall-paintings conserved and removed. The rectangular gap towards the right end of the long wall marks where bricks were taken away in 1926 to enable a painted panel to be removed. The line of three rectangular niches in the wall is part of an original line which extended for the full length. The scale bar has the length of 1 m.

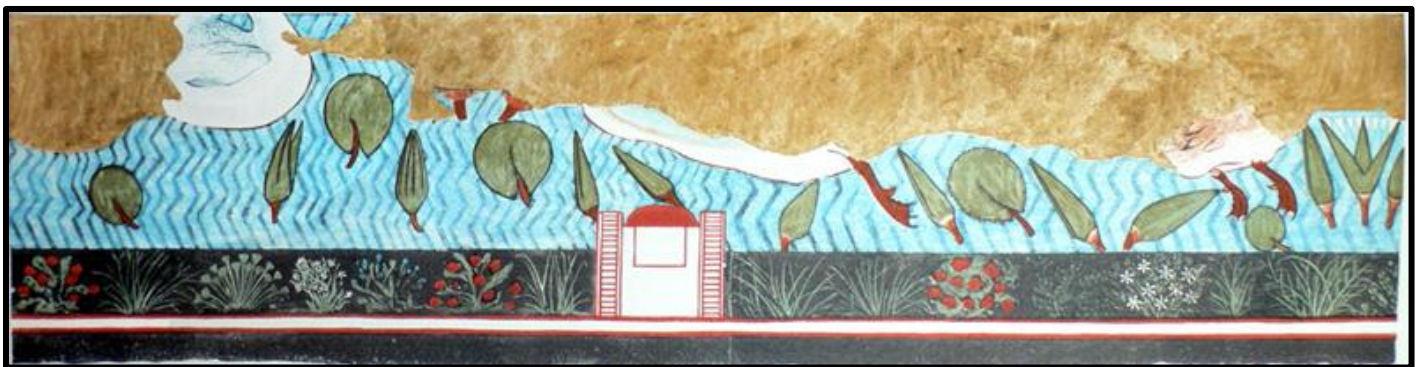
**Figure 9:** *The bottom of the waterbank scene shown in Figure 8. After the painted copy by Newton in Davies 1929: 69, Pl. VIIB.*

A second theme is the waterbank design (Weatherhead 2007: 147), remnants of which were found throughout the North Palace, including on the wall in the North-east Court which contained the viewing window (Figures 8 and 9) and the Green Room in the middle of the north side of the same court (Figure 10). In contrast to the fowl-feeding scenes, which are presided over by humans, the waterbank design depicts birds amidst thickets of riverside plants, including lotus (*Nymphaea caerulea*) and papyrus (*Cyperus papyrus*), with a stylised river at the base (although the example in Figure 9 includes a miniature landing quay). The Green Room (room 12)—one of two small, interconnected rooms (Figure 2)—was so named due to the dominant colour and extent of this theme (Davies 1929: 58). The adjoining room (room 11) was apparently an architectural duplicate providing the only access to the Green Room, though no artwork survived. Both rooms are characterised by two rows of niches in the walls (Figure 7), the significance of which has been the subject of much speculation (e.g. Davies 1929: 65–67). The niches were decorated to resemble small ponds (Figures 10 and 11) and it has been proposed that they may have held cut lotus and/or lily plants (Boyce in Weatherhead 2007: 166). The detailed, naturalistic execution of the waterbank design in the Green Room stood in marked contrast to the more standardised and formulaic renditions used in the palace, and transformed the Green Room into an 'idyllic landscape' (Weatherhead 2007: 157), where 'the disturbing presence of man is infinitely remote' (Davies 1929: 59).

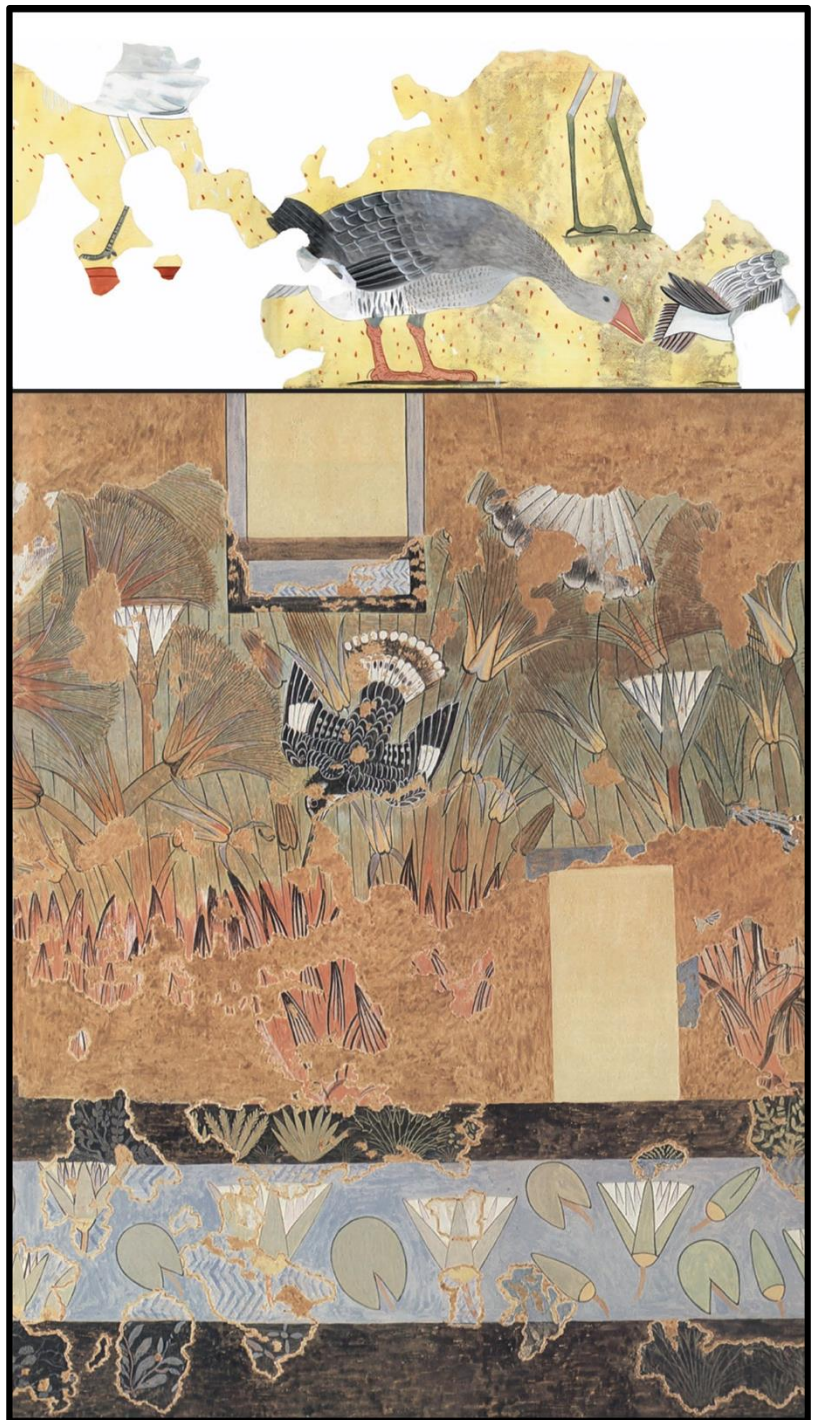
**Figure 11:** *Top: detail from a reconstruction of the fowl-feeding scene from the south wall of room 7 of the North-east Court. Original by Newton (EES archive). Bottom: excerpt from the waterbank design from the west wall of the Green Room, showing pied kingfisher (Ceryle rudis) and decorated niche (detail from N. de Garis Davies, Facsimile painting of the west wall from the 'Green Room' in the North Palace at Amarna; Public Domain; The Metropolitan Museum of Art, New York: accession no. 30.4.136).*

The pied kingfisher (*Ceryle rudis*) is one of, if not the most distinctive of the Green Room birds (Figure 11; see also Houlihan 1986: 114–116) and depictions of these kingfishers are common in ancient Egyptian art (El Menyawy 2020). This species is particularly conspicuous while fishing and hovering over water and likely a familiar sight along the Nile.

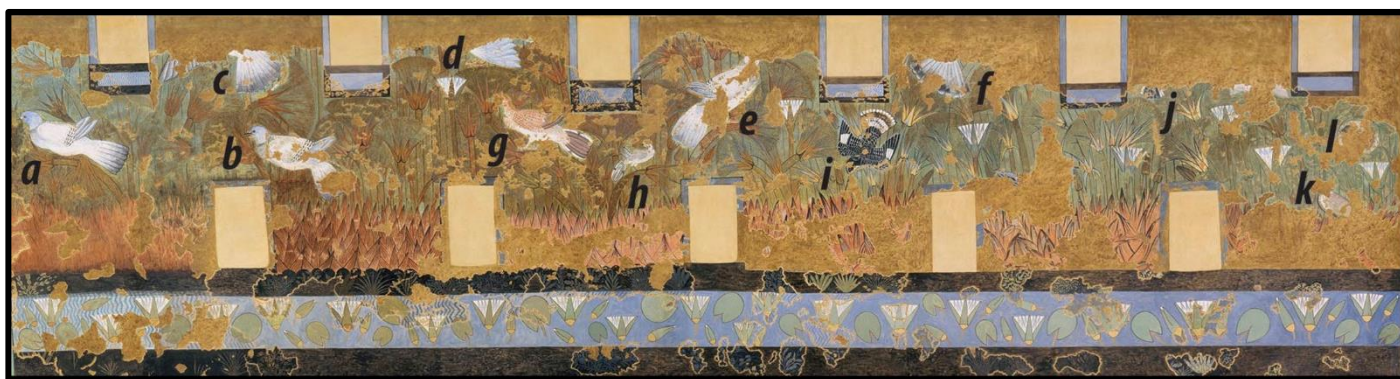
**Figure 13:** Proposed identifications of the birds of the west wall of the Green Room: a–f) rock pigeons (*Columba livia*); g) red-backed shrike (*Lanius collurio*); h) white wagtail (*Motacilla alba*); i) pied kingfisher (*Ceryle rudis*); j–l) unidentified. (Original image: N. de Garis Davies, Facsimile painting of the west wall from the 'Green Room' in the North Palace at Amarna; Public Domain; The Metropolitan Museum of Art, New York: accession no. 30.4.136).

Third, birds are shown perched and in one instance, nesting atop papyrus umbels in the Green Room panels (Figure 13). Papyrus umbels could not support a birds' weight and would not provide a solid support for nesting. The Green Room examples do make some concession to physics and show stems bending under the weight of all but one of the perched birds; curiously, bird b seems to be suspended in mid-air (Houlihan 1986: 101) (Figure 14), although this may reflect an attempt to depict the bird slightly deeper within the thicket of plants (*cf.* Evans 2010: 43). Overall, the depiction of birds on the umbels is most reasonably explained as a stylistic convenience.

There are also anomalies that are unique to Amarna. The folded primary feathers of the perched birds in the west wall panel all feature a peculiar bend at an angle of approximately 45° (Figure 13). This characteristic occurs independently of species and of theme: bent primary feathers are also portrayed in the fowl-feeding scene in room 7 (Figure 11) and appears to have been a local convention. Davies (1929: 64) speculated that this may have been the result of a foreign stylistic influence or, alternatively, that the wings of the original birds used as models were bound or that their feathers were broken. To our knowledge, the latter scenario had not been required over centuries of portraying birds in ancient Egyptian art; it would also seem unnecessary to hobble or handicap a tame goose (and, arguably, commensals such as pigeons or doves) in the face of a

Images of 12 (possibly 13) birds were recorded on the west wall panel (Figure 13: birds a–l) of which nine were reasonably well preserved (a–i). The remainder (birds j–l), including a small bird nesting amidst the papyrus (bird l), cannot be identified.

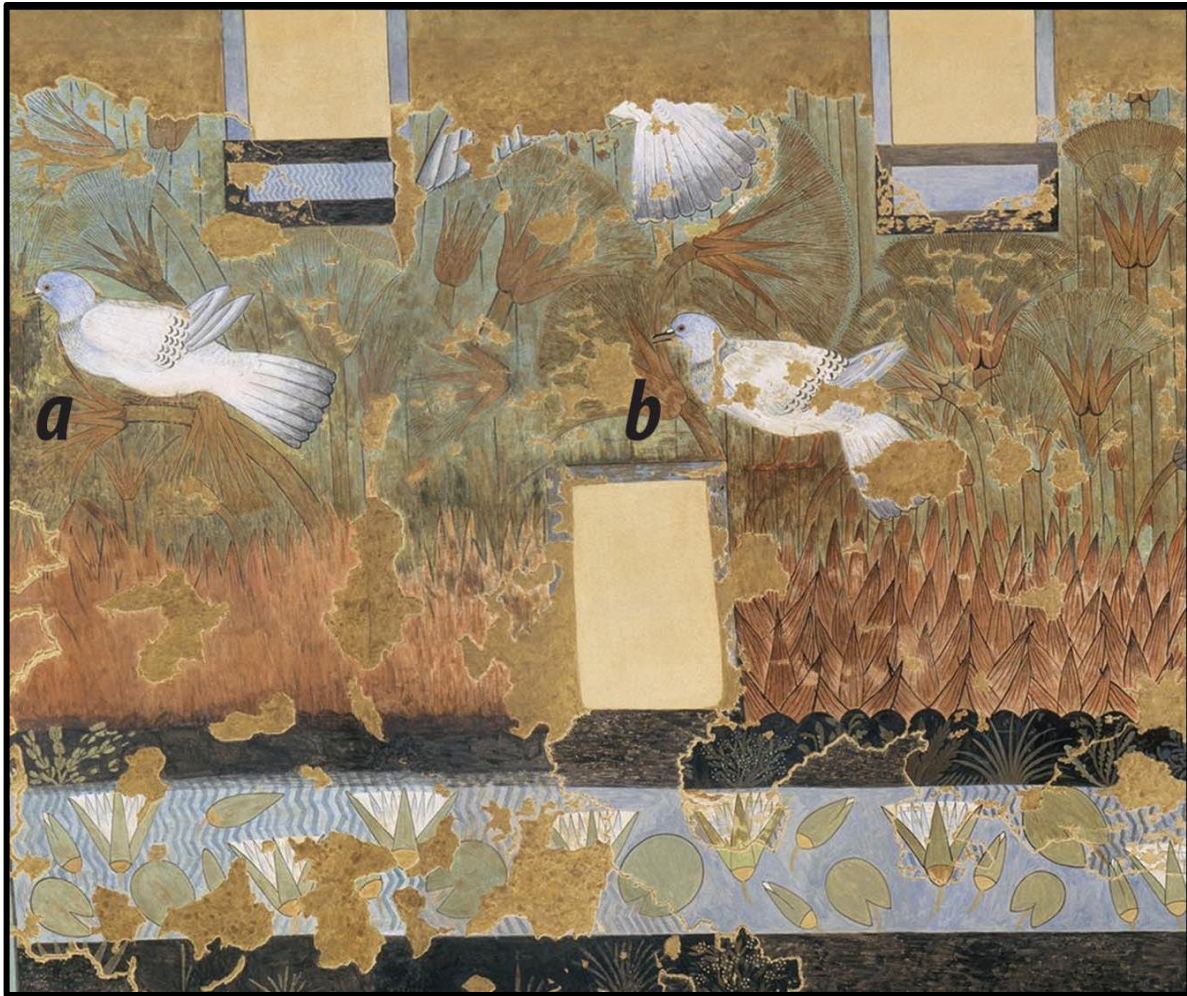
**Figure 14:** *Birds a and b: rock pigeons (Columba livia). Detail from N. de Garis Davies, Facsimile painting of the west wall from the 'Green Room' in the North Palace at Amarna. Public Domain; The Metropolitan Museum of Art, New York: accession no. 30.4.136).*

Most of the identifiable images are a species of pigeon (*Columba* sp.), one of which (bird b) has been the subject of detailed description by Houlihan (1986: 101–103). Depictions of pigeons in ancient Egyptian art are not uncommon or unique to the Green Room. Renditions of the rock pigeon (*Columba livia*), however, are rare. Bird b (Figure 14) is a fine example of this species and shows a remarkable attention to detail and an appreciation of plumage and morphology (Houlihan 1986: 103). There are at least six pigeons shown in the panel (a–f) and the presence of wing bars (Gibbs *et al.* 2001: 176) on the three perching birds (a, b and e) are suggestive of this species (see below). The remaining three birds, which are in flight (c, d and f), are also likely to be rock pigeons but lack diagnostic characteristics.

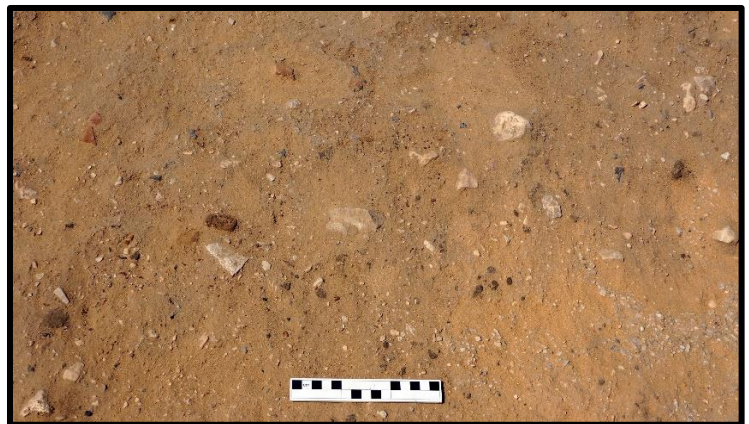
**Figure 3:** Detail of the trampled incense and date seeds over the exterior mud floor 19714. West is towards the top.

Embedded in the surface of mud floor 19714 were seeds of different species and incense in the form of dark ruddy-orange filaments, and more rarely, in lumps resembling glass (Figure 3). It also seemed, whilst collecting the sample for home sieving due to the quantity found (respectively 2.43 g and 40.77 g in total), that this material might have in part belonged to the making of the mud floor

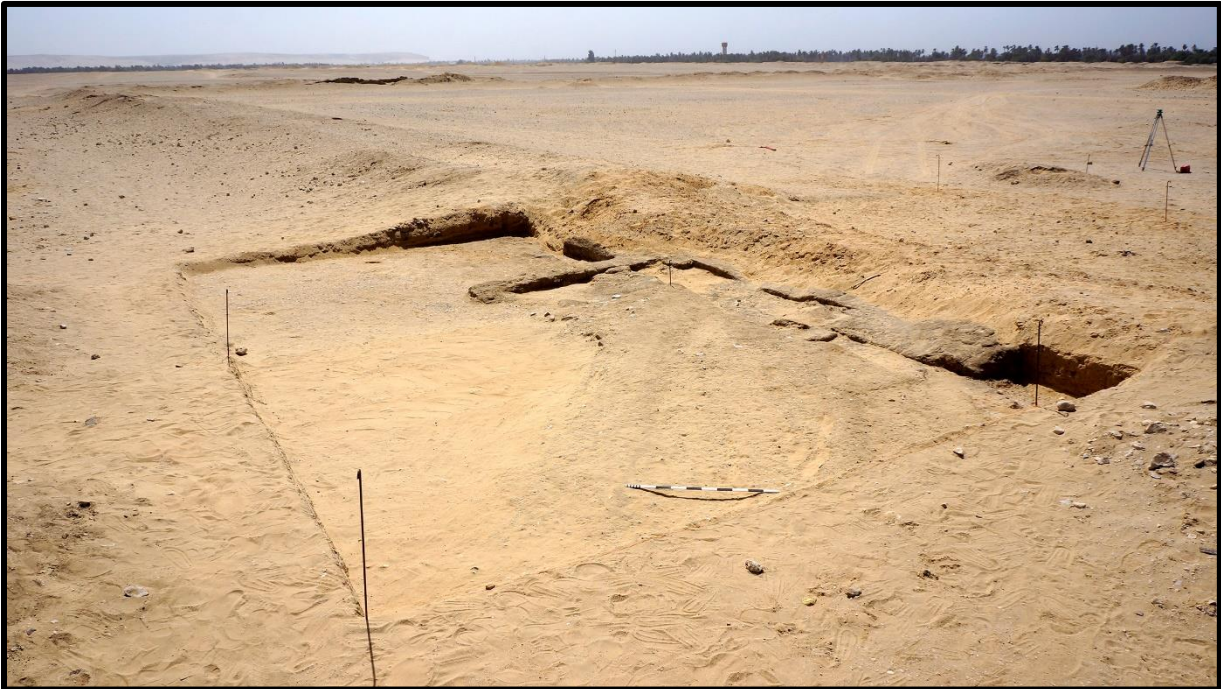
**Figure 4:** *View, towards the south-west, of the tyre tracks passing through the mud-brick ramp. The gate itself is still covered by the sandy backfill from 2021.*

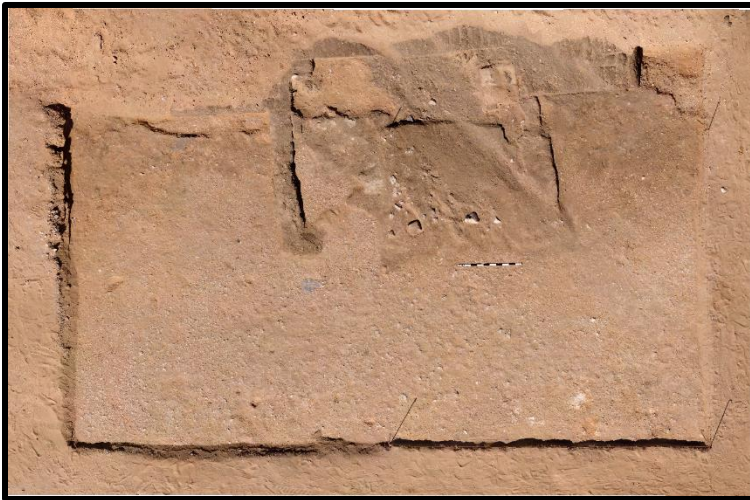
**Figure 5:** *The mud-brick ramp of access outside the temple precinct. North is on the right. Orthomosaic by Fabien Balestra.*

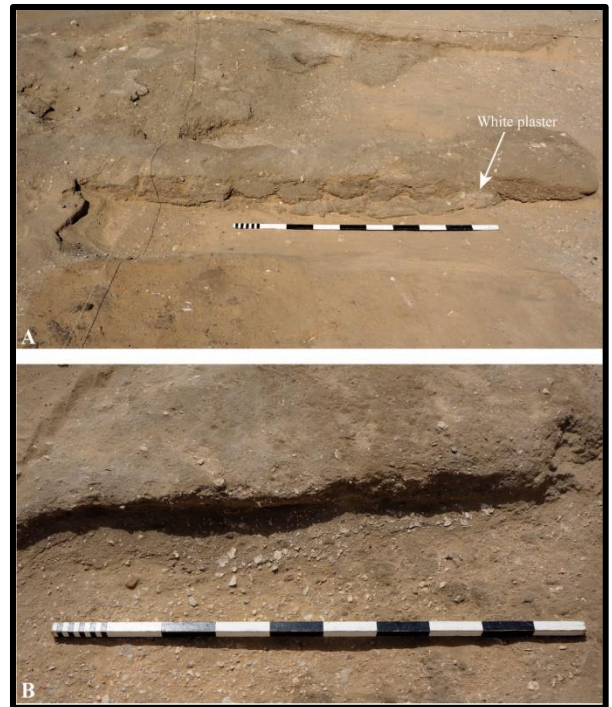
**Figure 6:** *(A) The exposed white plaster on the southern face of the framing mud-brick wall [19910] of the ramp in 2021; (B) the whitewash over the mud floor 19714 near the northern edge of the boundary wall [20383] of the ramp in 2022.*

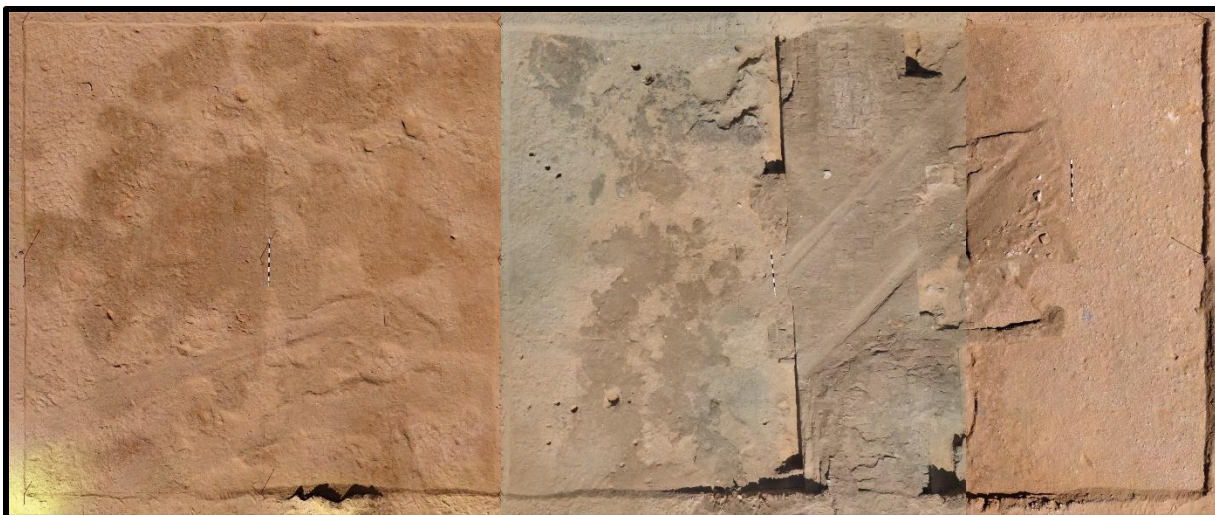
**Figure 7:** Collage of the 10 squares excavated at the East Gateway in 2021 and 2022. North is towards the top. Orthomosaics by Fabien Balestra.

The removal of Pendlebury's spoil heaps (19792 and 20376), the overburdens (20378 and 20390) and the earlier thin gravelly and sandy deposits (20379 and 20388) revealed the continuation of the mud floor 20386 toward the Sanctuary. It is important to state that the 5–10 cm of topsoil on the westernmost squares directly covered the mud floor, leaving the ancient surface and features at a high risk of damage. More to the east, the original ground surface lay beneath different collapsed contexts as exposed in 2021 (Figures 7 and 8).

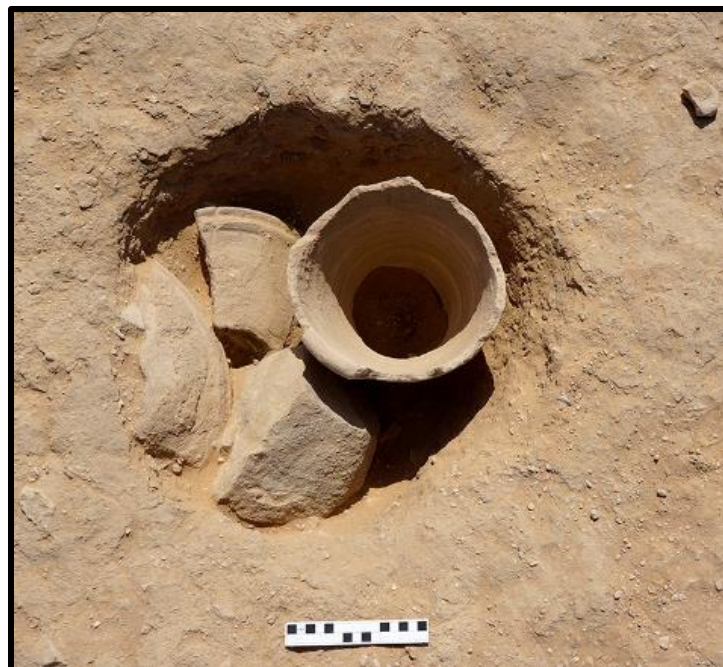
**Figure 9:** The pot (object 44135) in situ stabilised by a medium-sized unworked lump of indurated limestone and a large broken plate (object 44121). A miniature vessel is also visible lying on the mud floor in the top right corner. South is towards the top.

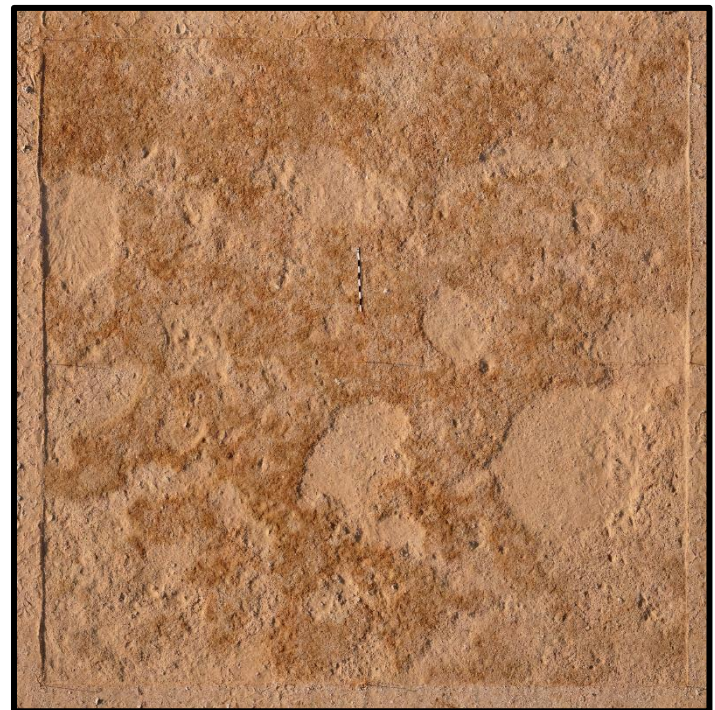
**Figure 12:** *Overview of the mid-excavation stage in sector 2, showing the yellow sandy patches over the mud floor 20116. North is at the top. Orthomosaic by Fabien Balestra.*

These latest deposits also covered several loose yellow sandy patches of circular and irregular shapes of different sizes (Figures 12 and 13). Their removal revealed that they were either the upper layers of pits, pot-holes, post-holes or, more likely, animal burrows owing to the lack of a consistent pattern.

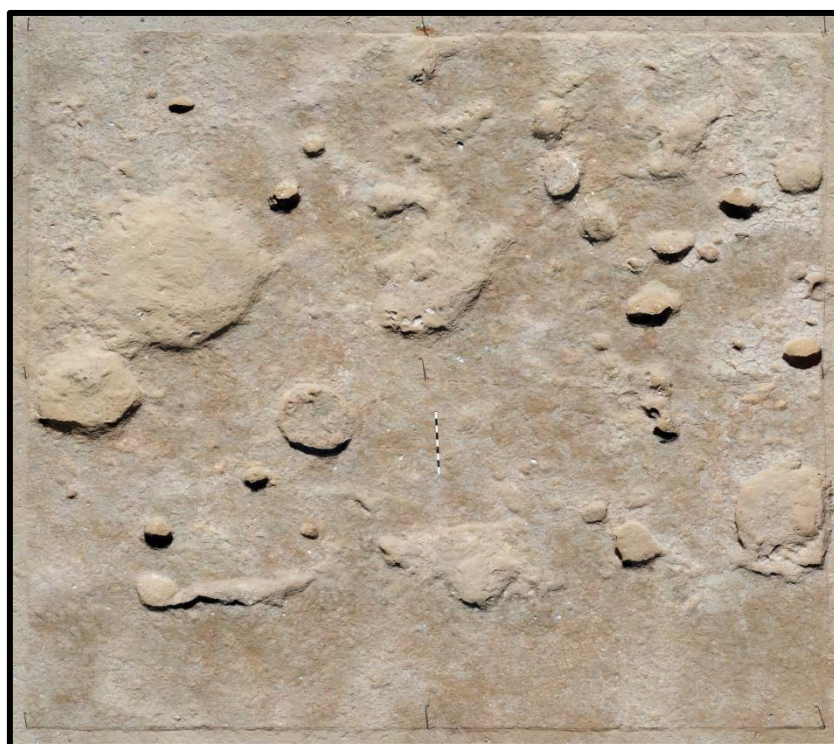
**Figure 13:** The pilot area at the end of the work. North is towards the top. Orthomosaic by Fabien Balestra.

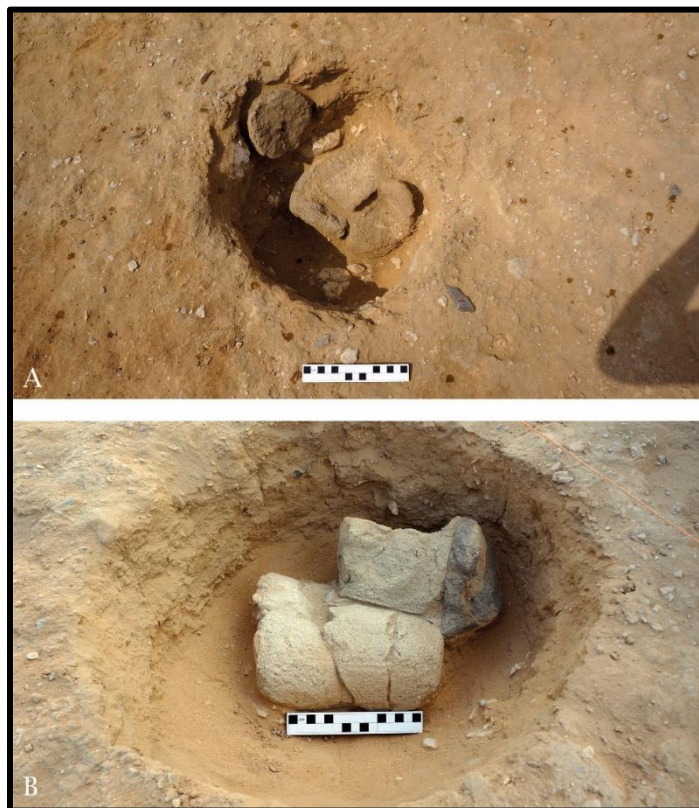
**Figure 16:** (A) Groups of jar sealings found in pothole <20600> and (B) in pit <20582>.

Out of 36 hollow structures observed, eleven were seen as potholes because of their dimensions, contents, and distribution (Table 2). Although they all contained potsherds in various quantities, one is worth mentioning separately because of the material found within. The pothole <20604> yielded a group of potsherds to which was attached mud (mortar?) upon which were plant and stem impressions (Figure 14). The question whether this material could have been part of a building structure (e.g. roofing) remains to be answered since it was the only sample discovered. Its fill also provided seeds (0.61 g), amongst them grapes, as well as a small quantity of incense (1.70 g). In contrast to other collected samples, these resinous items were brownish, fragile, fine filaments and lumps (Figure 15). Similar material was found in autumn 2022 under the 'causeway' in the Fourth Court of the Long Temple. The change of colour might have one of three origins: it is the result of a temperature difference whilst the viscous liquid was being poured through the strainer; the variation was caused by the incense quality itself; a difference in its components is the explanation. These postulates can only be answered through archaeological experiments and laboratory analyses. The pothole <20604> was found next to the sunken fireplace <20607>. This structure measured 56 cm in diameter and yielded various seed species, charcoal and tiny burnt branches of species also yet to be determined. Another structure worth singling out is the pothole <20600>. Only a few centimetres south of <20598>, a group of jar sealings was discovered in its cut along with a number of potsherds. On the east part, pit <20582> contained another group (Figure 16).

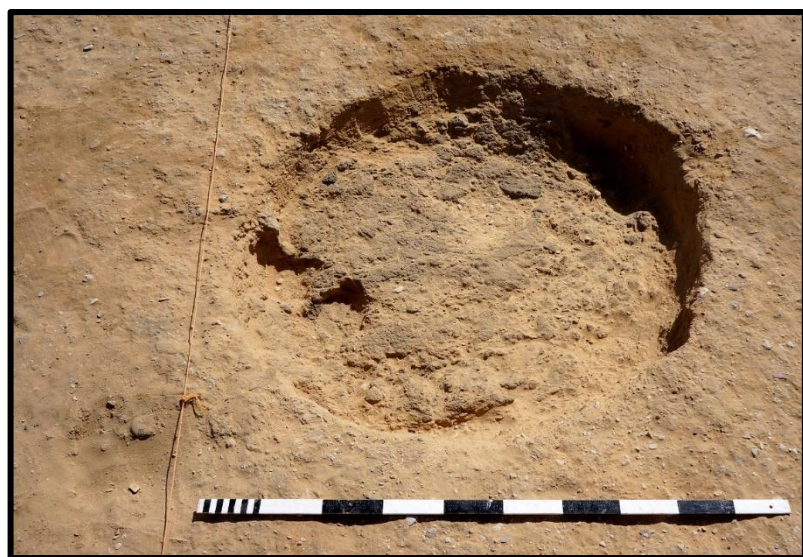
**Figure 17:** The clay base of the puddling pit <20517>. The two possible pots impressions are on the left. North is on the left.

These potholes seem overall to be gathered in group of three or four and to be mostly located in the west part of the examined zone along with the biggest pits. The largest, <20513>, measured 2.30 x 2.40 m but was only 23 cm deep. It consisted of two sandy layers, differing in the presence of mud fragments and broken jar sealings. The upper deposit (20512) appeared to cover another smaller pit, <20529>, situated a few centimetres south-west. Its second fill was a mix of yellow sand and crumbled mud fragments. Jar sealings were also found within it. A similar pit, <20522>, was noticed opposite to the latter. In the centre of the zone, two pits are worth citing: one, <20515>, of irregular shape contained a wavy-rimmed pottery bowl but without decoration on the outside (Figure 27, object 44120). The second, pit <20517>, measuring 1 m diameter and 17 cm deep, is reminiscent of a puddling pit owing to the presence of a clay base layer extending up the edges. Its excavation provided grape seeds in great quantity and good shape (0.43) that seem to have spent time inside a liquid of some sort rather than having been crushed, pressed or chewed (personal discussion with Alan Clapham, archaeobotanist). Circular marks were also noticed at the bottom of the pit, leaving the feeling of being perhaps the impressions of small pots, unless they are the remains of animal burrows (Figure 17).

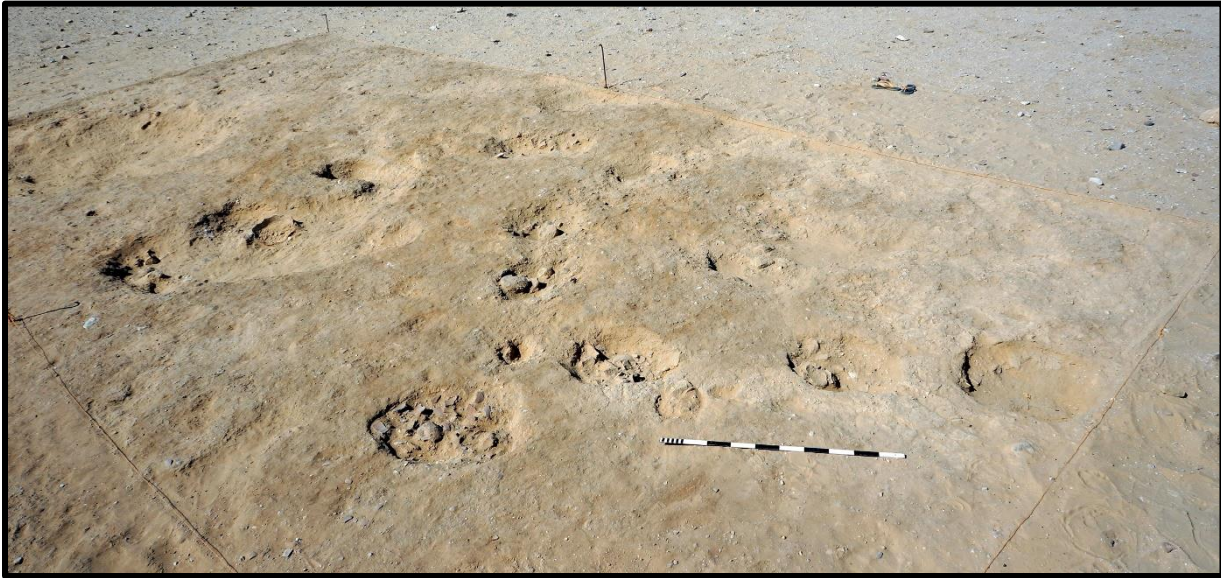
**Figure 19:** *Pits arranged in a circular pattern in the north-east part of sector 2 showing the material (primarily potsherds) contained within. View looking north-west.*

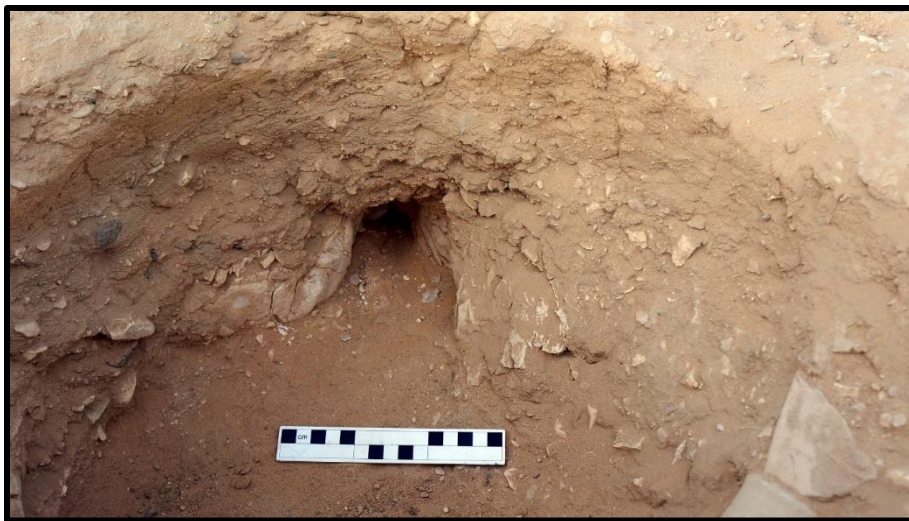
**Figure 20:** *Animal burrow seen within the pit <20570>.*

The rest of the hollow structures must be divided between pits and postholes or animal burrows according to their smallness. How the pits were distributed in the north-west corner of the area may imply that they were dug later: they all gather in a roughly circular pattern, although the full extent remains to be seen (Figures 13, 19; Table 3). Out of seven, four yielded numerous, fragmented and very fragile jar-sealings, of which a large proportion was stamped, indicating that they had closed wine containers for the 'House of the Aten', that is, the Great Aten Temple. Besides, the origin of the wine remains unknown since no jar labels with supplementary information were found. Animal burrows were identified within some of the hollow structures (Figure 20).

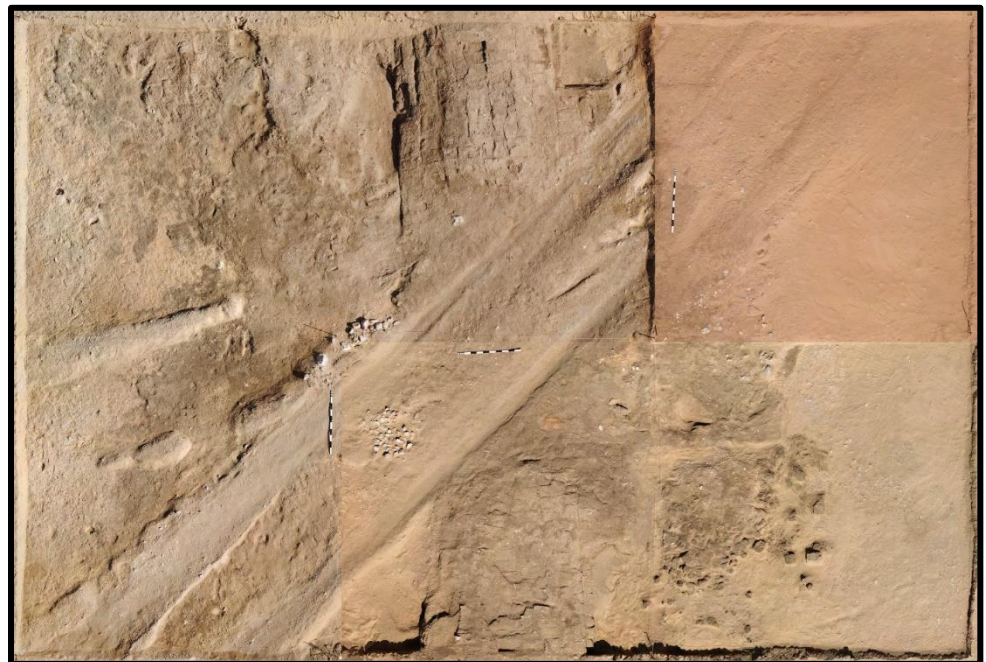
**Figure 21:** *Collage of aerial photographs taken in 2021 and 2022 showing the tyre tracks damaging the East Gateway. Orthomosaics by Fabien Balestra.*

a road that the hollow depressions had badly damaged the archaeological structures. The removal of the latest deposits and the careful excavation of the area showed that the tyre tracks had penetrated deep into the upper fill of the ramp before turning at almost a right angle to continue northwards. The action of the latter had flattened the extremity of the northern framing wall of the ramp. The second set of traces, north of the others and almost parallel to them, were found inside the enclosure wall of the temple. They also had marked the mud floor surface even if they were less striking, gradually vanishing eastwards. Indeed, these depressions were only noticed in 2021 (Figure 8).

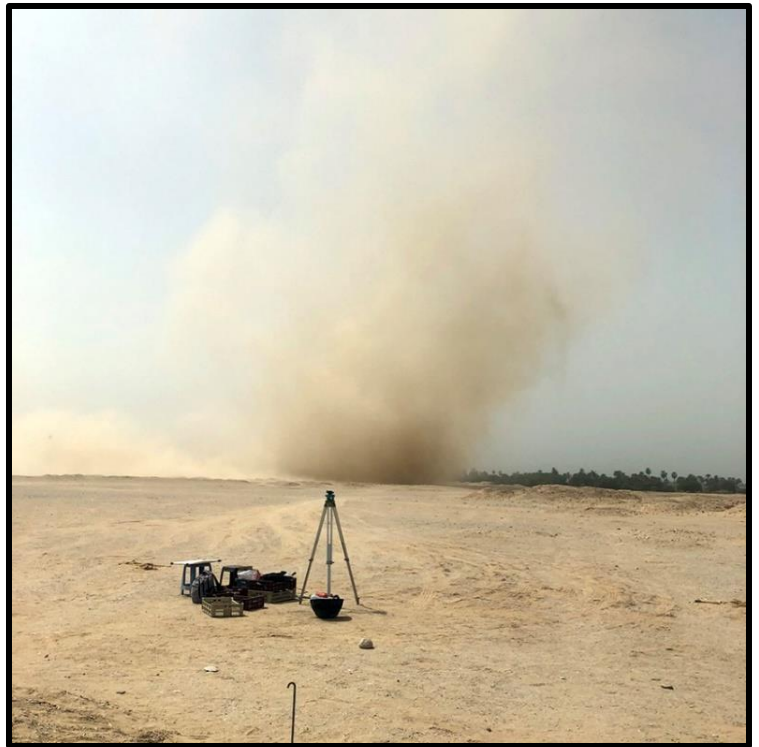
**Figure 22:** A 'Dust Devil' hitting the archaeological site in 2022. View facing south-west.

The archaeological site also remains under natural threats, being subject to strong winds that cause erosion (Figure 22).

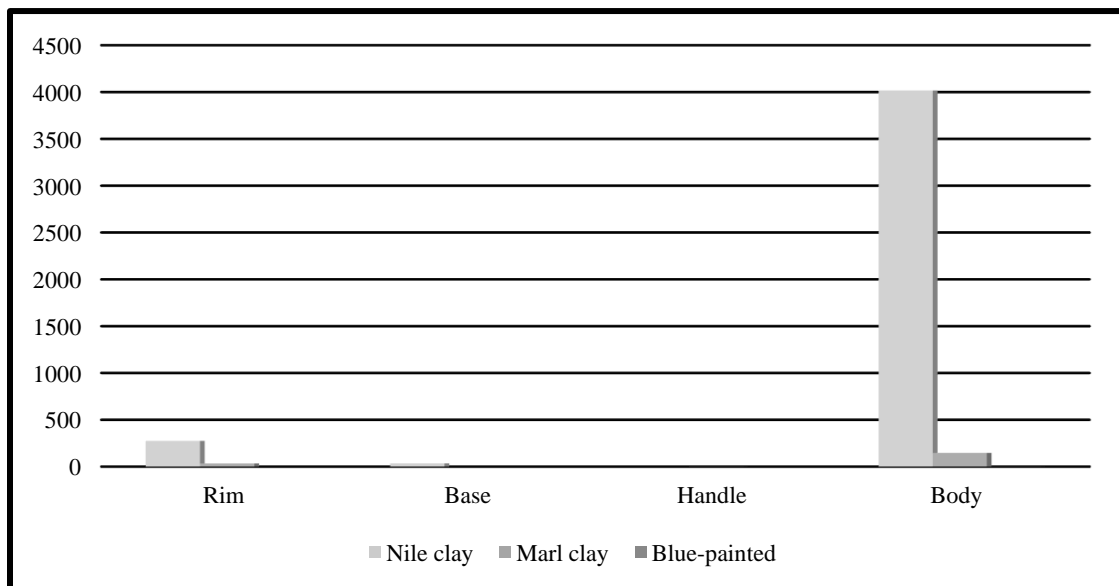
**Figure 24:** Distribution of sherds found in the pilot area (sector 2) by type of fragmentation and fabric.

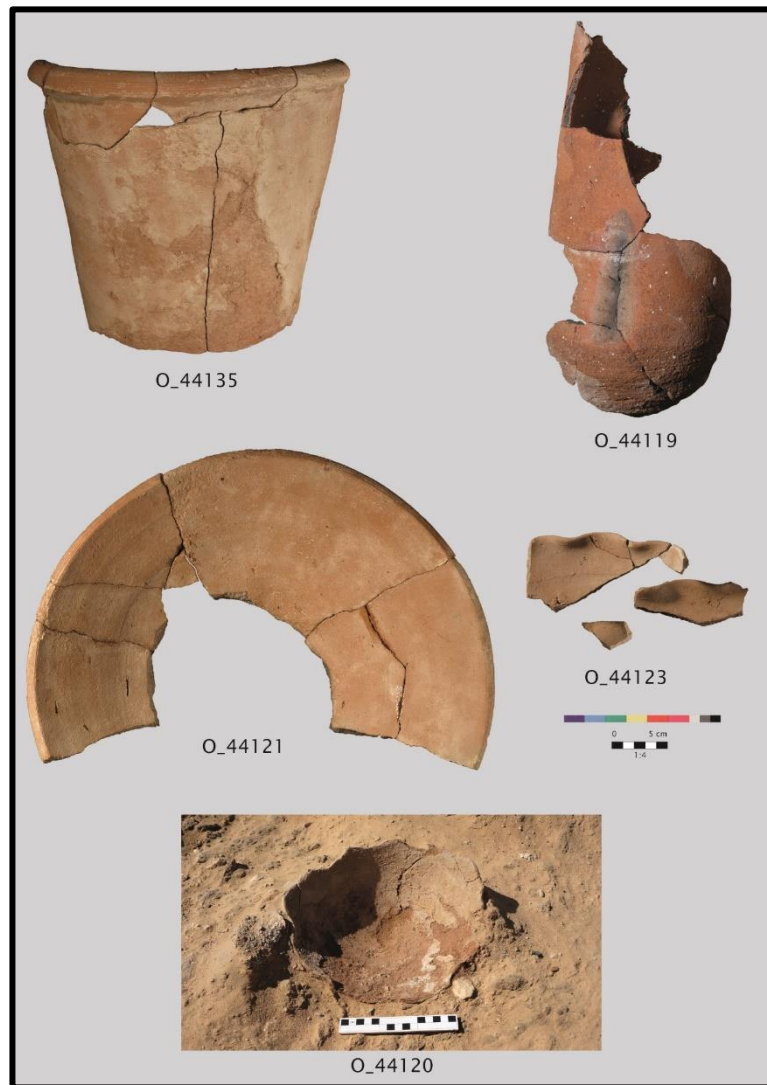
**Figure 27:** Pottery sample. Photographs by Andreas Mesli.

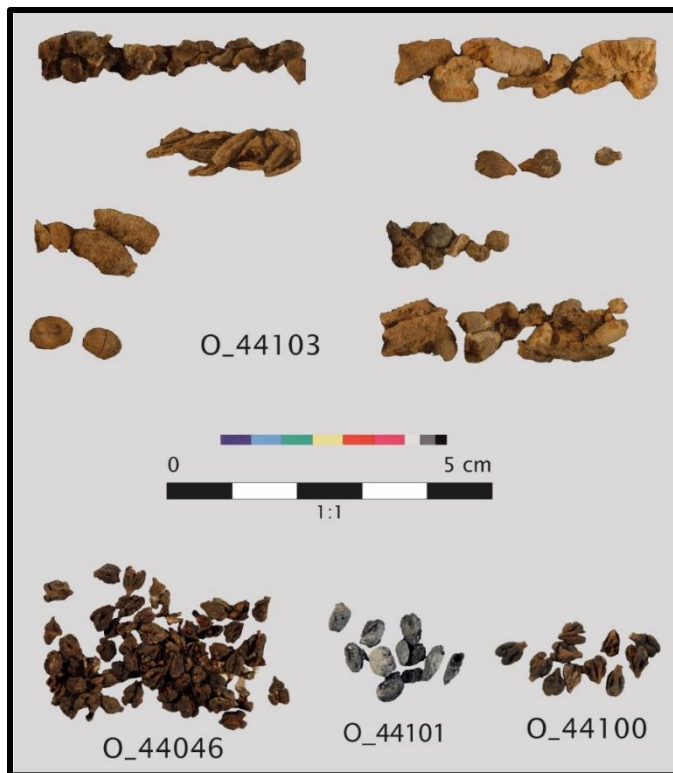
**Figure 28:** Selection of seeds discovered in 2022.
